Identification of Acoustic Emission Source and Comparative Study on the Diagnosis of a Spur Gearbox

Lokesh. G. Kamde, Suryabhan. A. Patil, Asso. Prof. U. N. Gujar

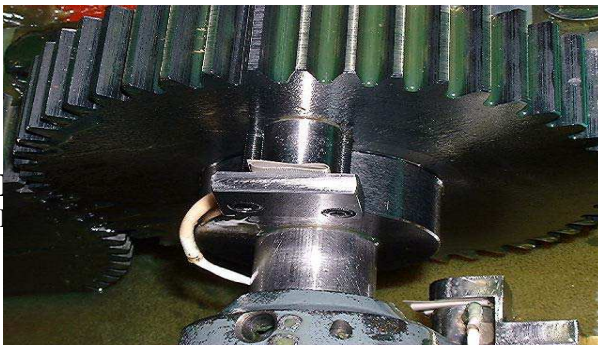
Fig.No.2 AE sensor located on pinion.

The AE sensors used here is wide band type sensors with a relative flat response between 100 kHz and 1 MHz (WD model, ‘Physical Acoustics Corporation’). An AE sensor was placed on the pinion (49 teeth), as shown in “Fig.No.2”. The cable connecting the pinion sensor was fed into the pinion shaft to the pre-amplifier via a slip ring. This allows the AE sensor to be placed as close as possible to the gear teeth. Both the sensors are hold in place with mechanical fixtures. An ‘IDM Electronics Ltd’ manufactured PH-12 slip ring is used. The slip ring used sliver contact and could accommodate a maximum of 12 channels. The cooling air pressure for the slip ring is 1400 kg/mm². Pre-amplification was set at 40dB. The signal output from the preamplifier is connected directly to a commercial data acquisition card. The data acquisition card could provide 10 MHz sampling rate and incorporated 16-bit precision giving a dynamic range of more than 85 dB. Prior to the analog-to-digital converter (ADC), the card uses anti-aliasing filters that can be controlled directly in software. A K-type thermal couple, rated from – 200⁰ C to 1378⁰ C is used to measure

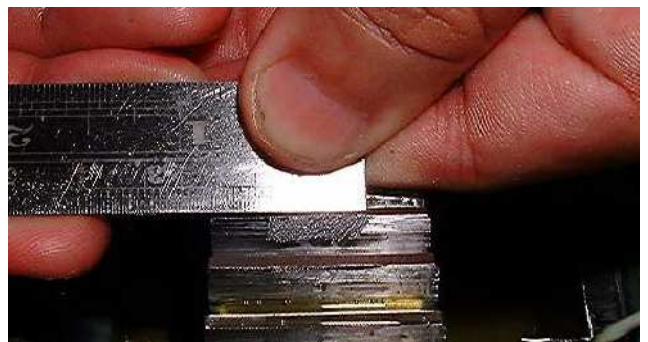
Fig.No.4 Seeded large addendum defect.

Before starting an experiment the gearbox is allowed to operate for 15 hours. After that a large addendum defect (extended from the pitch-line) measuring 12 mm along the face width and 3 mm from the pitch-line to the gear tip is seeded on one of the pinion tooth surface as shown in “Fig.No.4”. Total five experimental combinations is undertaken: two speed and three load conditions. For each test condition, the gearbox is allowed to run from a cold start for several hours until the oil temperature reached equilibrium, i.e. it reach a
